Combustion Device Failures During Space Shuttle Main Engine Development

Otto K. Goetz
NASA

**5th International Symposium on Liquid Space Propulsion
Long Life Combustion Devices Technology**

Chattanooga, Tennessee
October 27-30, 2003

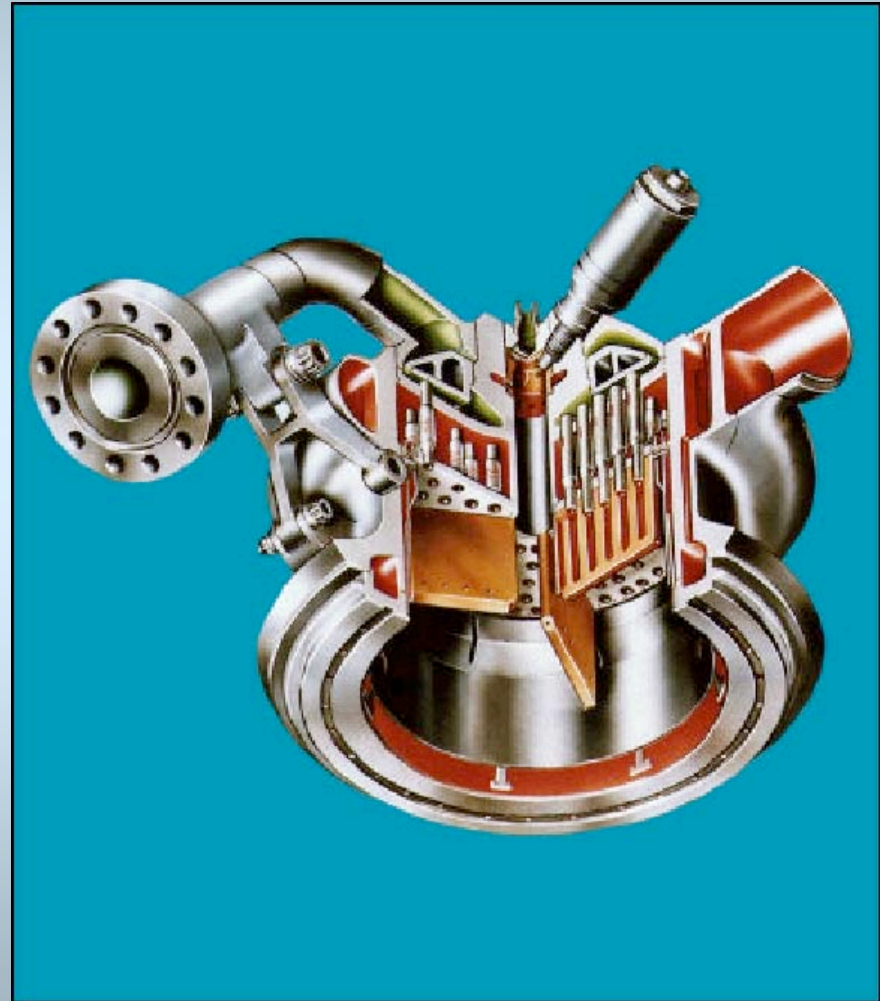
Engine 2106, Test 902428, July 1, 1987

Failure: Interpropellant braze joint

Post test inspections revealed moderate erosion in one quadrant on the OPB faceplate and a hole through the HPOTP turbine inlet sheet metal. Leakage tests of the OPB interpropellant plate conducted on the engine revealed leak at baffle number 2, row A pin (2A).

Cause: Poor quality braze joints (greater than 90 percent porosity) at row A baffle pin to interpropellant plate joint. The large porosity was related to poor process control techniques used in the laboratory furnace. The poor quality braze joint failure was most probably due to low cycle fatigue.

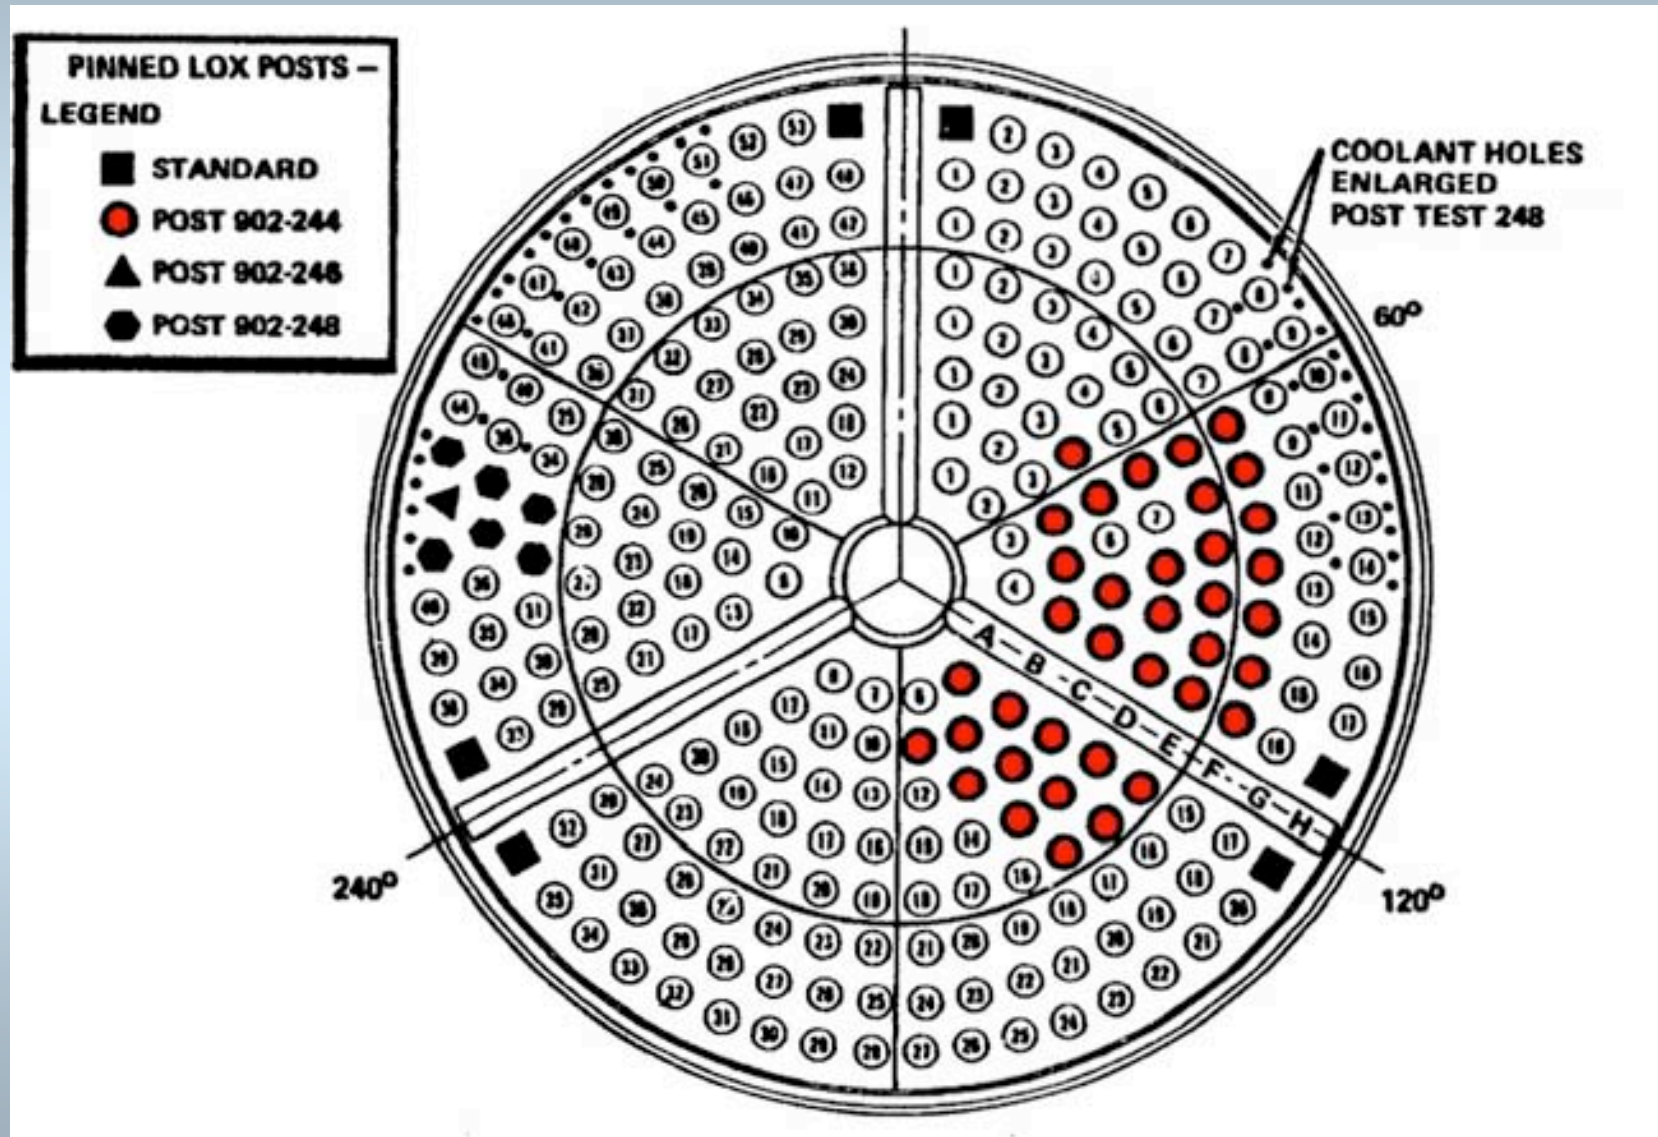
Cause: FPB injector face had experienced damage during a prior test and had been repaired by plugging several oxidizer posts in one quadrant resulting in a circumferential temperature gradient in the preburner. Localized high temperature streaking caused disbonding of the first stage turbine tip seals; excessive rubbing of the blades caused blade failure, sudden rotor speed decay and resulting HPFTP inlet volute rupture and Lox rich shutdown.

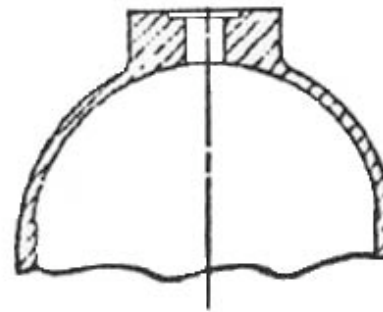
Integrally Machined Bosses

Powerhead 0007 and subs

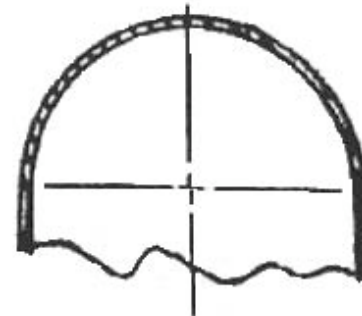
Bosses Eliminated

Powerhead 2004 and subs

All Flight Engines

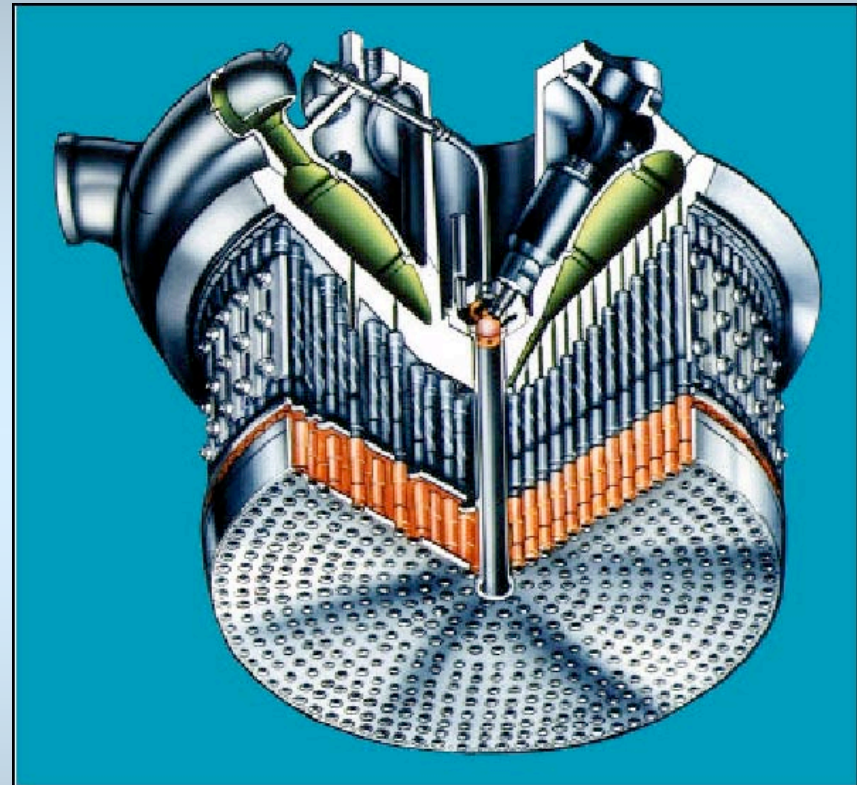
Engine 2108 Test 901331, July 15, 1981

Failure: Lox injector post crack

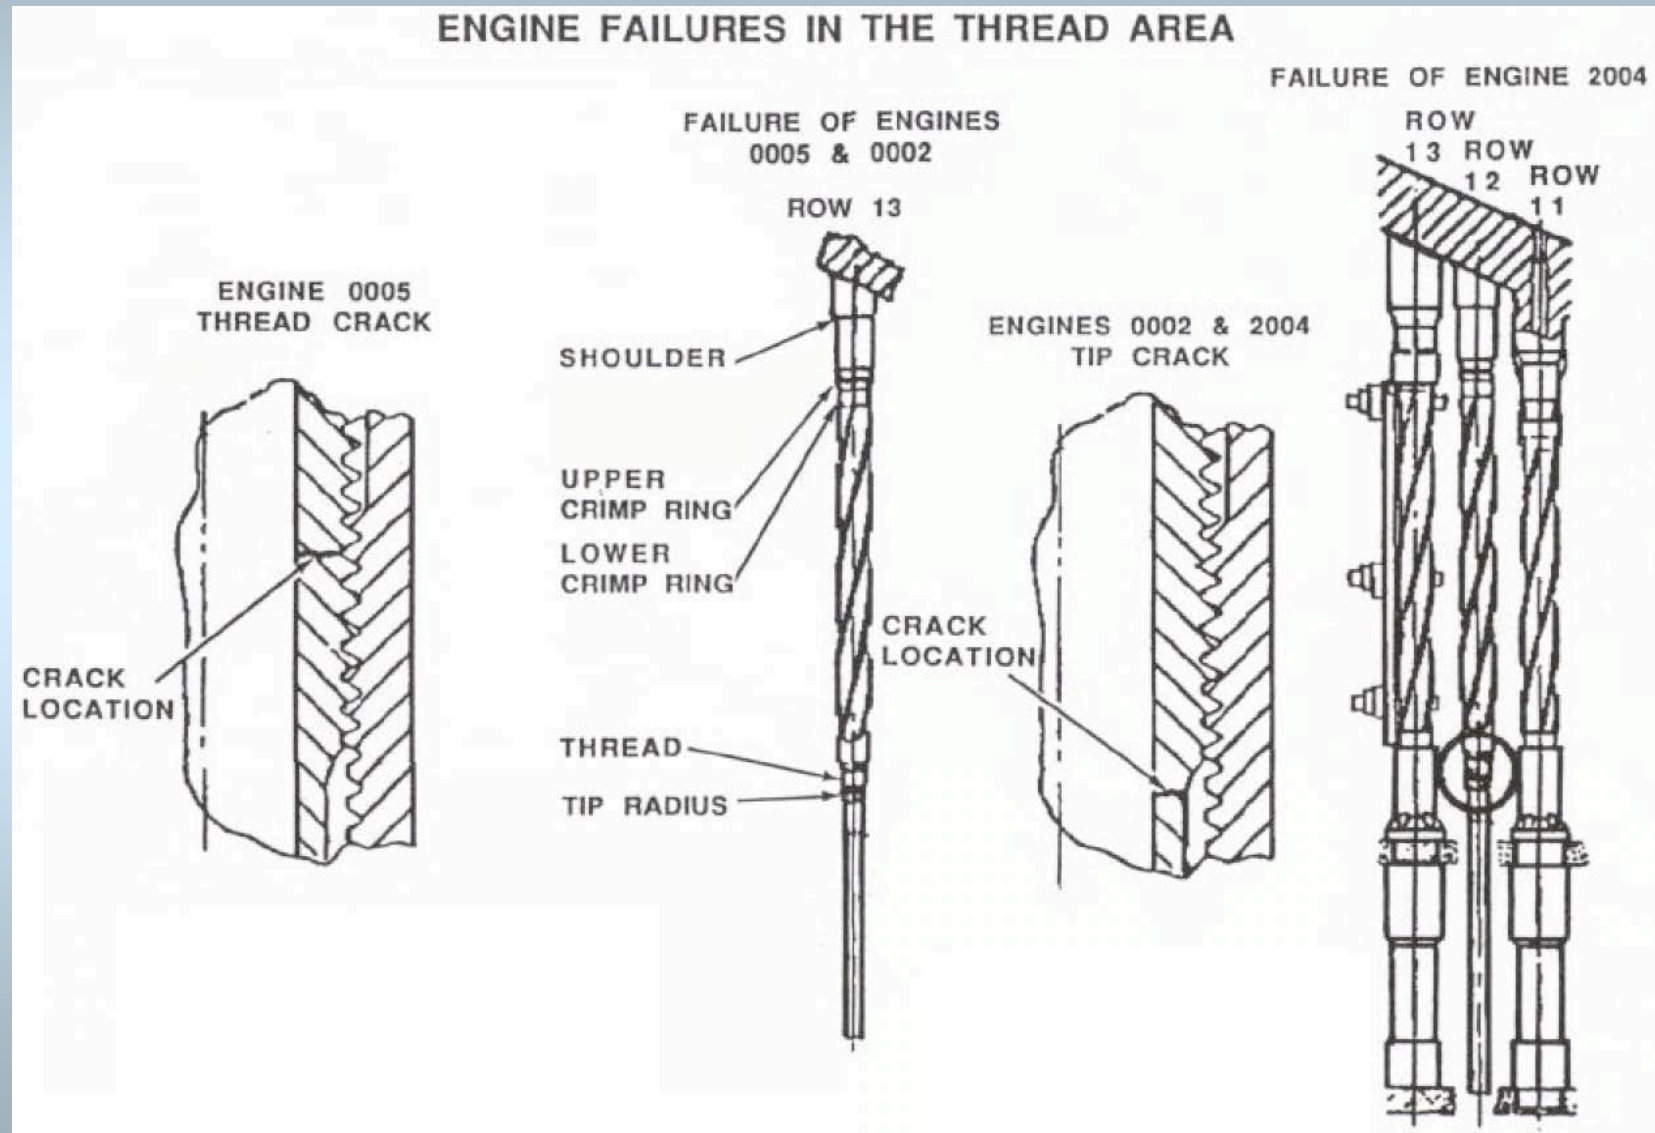
Cause: The cause of the failure was high cycle fatigue of the Lox post due to flow and mechanical vibration. Metallographical examination of the disassembled injector in rows 13, 12, and 11 revealed that 62 posts were cracked. A cross section of the fillet area of post 61 in row 12 revealed longitudinal wavy lines indicative of the type of cold working accompanying HCF. Visual observation earlier in the disassembly of the injector indicated that post 61, row 12, was the failed post. Post 61 had the most uniform burning with molten metal and slag 360°. The high cycle fatigue of the Lox posts was caused by mechanical vibration of the powerhead and flow induced vibration from the hot gas combined with high steady-state stresses.

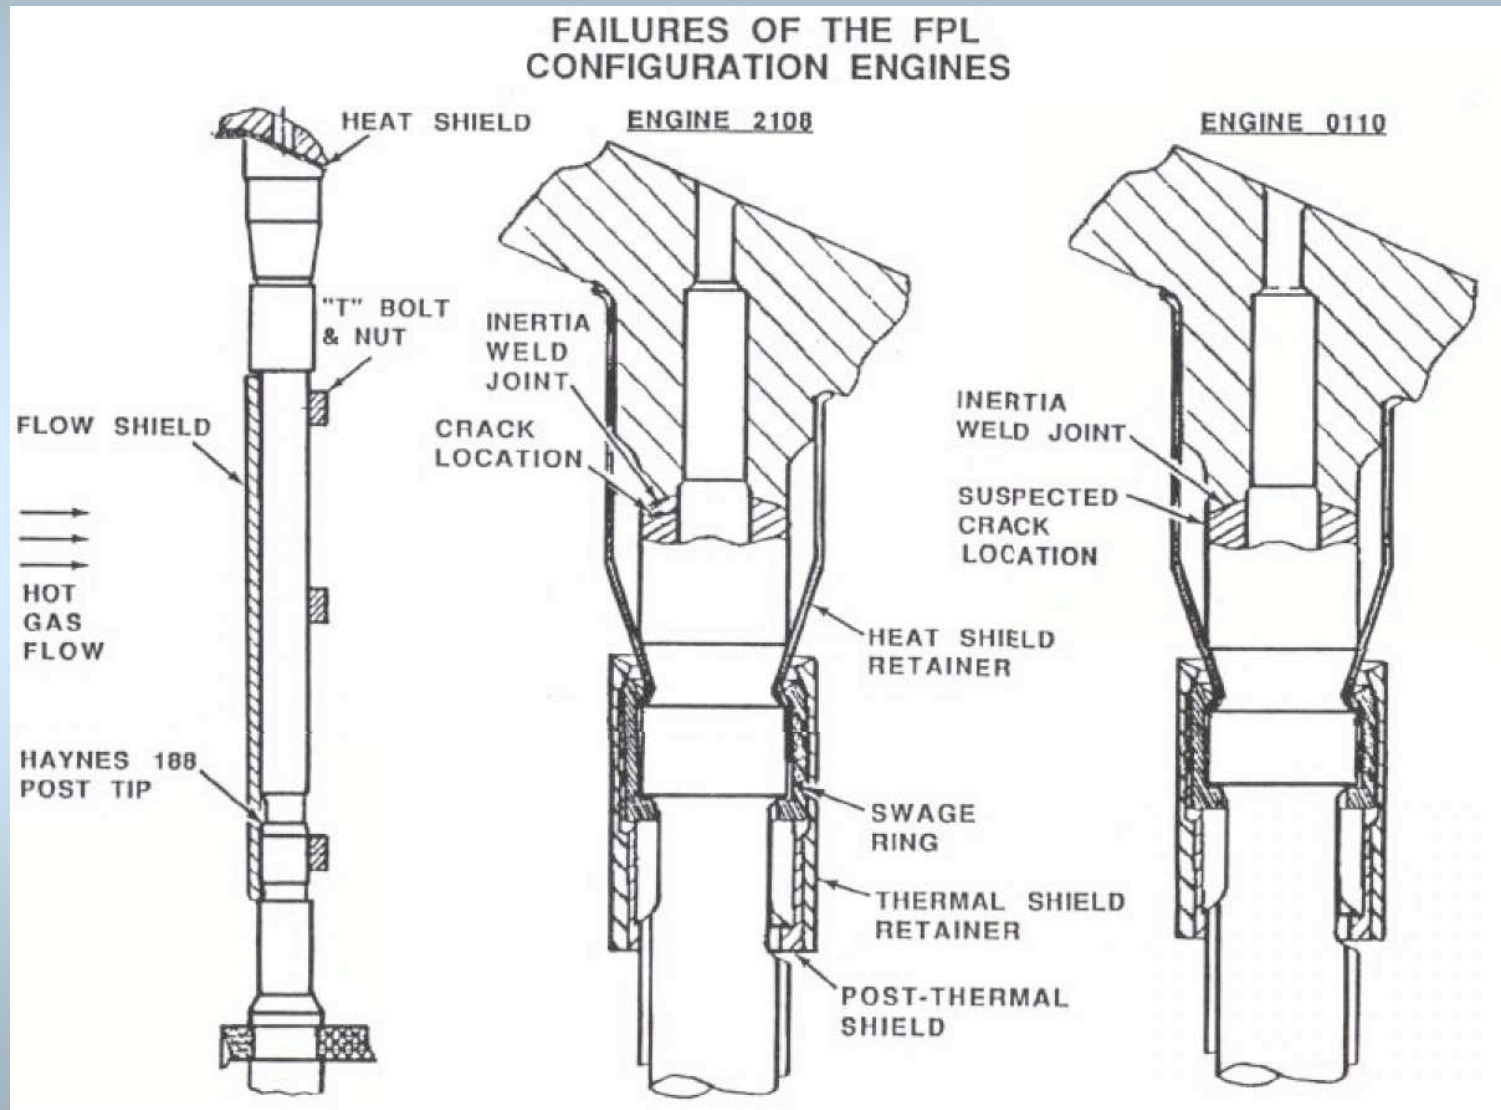
Cause: Lox post number 79 in row 13 failed in the 316L material at the inertial weld (which joins a 316L post to an INC0718 interpropellant plate stub) . The post failure was caused by high cycle fatigue. There was a much larger increase in flow induced vibration in going from RPL to FPL; than had been estimated in life calculations. Furthermore, the modifications which had been made in the high pressure fuel pump to adapt it to FPL operation increased the severity of the flow induced vibrations at all power levels.

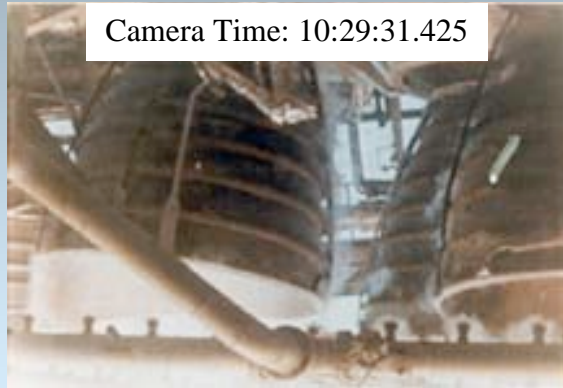
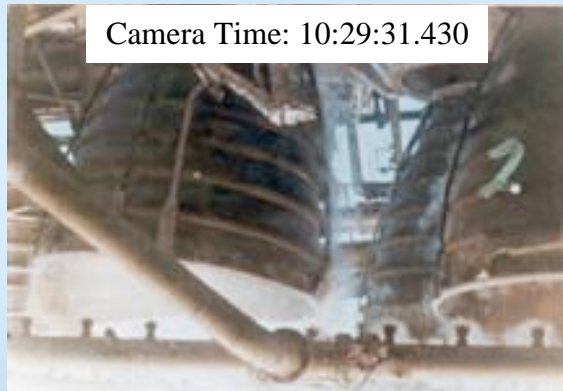
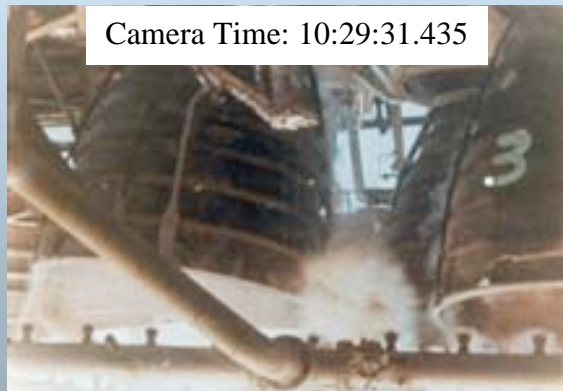
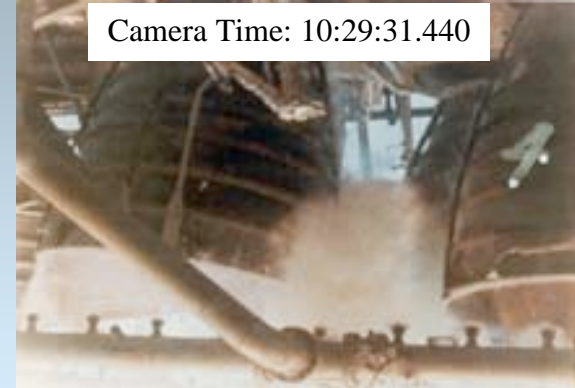
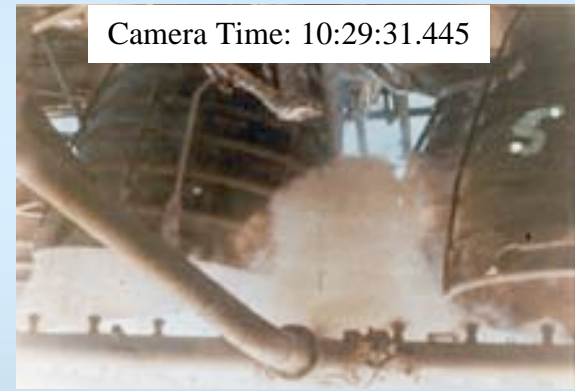
Test SF6-3, Engine S/N 2002

Cause: The steerhorn failure occurred during the period of maximum nozzle deflections due to exhaust plume separation; however, the data obtained from strain gage measurements located on the steerhorn were below the levels necessary to fail the steerhorn. Subsequent investigations revealed that improper weld rod material was utilized in the fabrication of the steerhorn which significantly reduced the load carrying capability of the assembly.

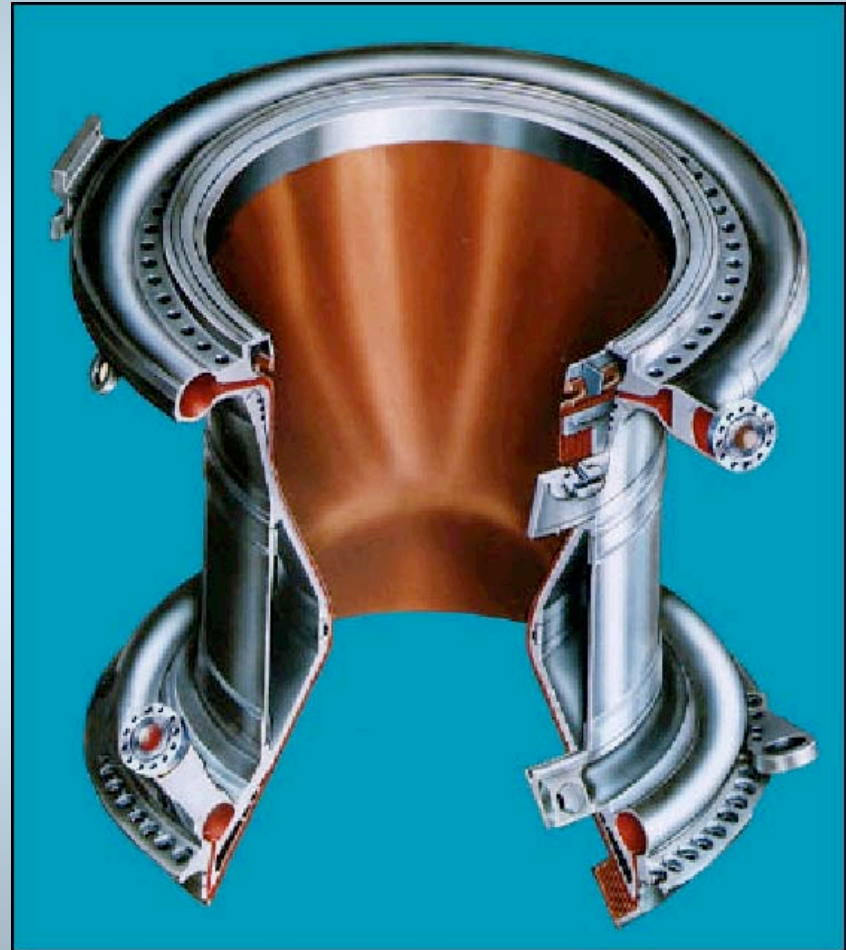
Engine 2308, Test 750259, March 27, 1985

Failure: Failure: Outlet neck rupture
